In-depth Study on Road Accidents: Thailand Perspective

Thailand Accident Research Center (TARC)

Asian Institute of Technology (AIT)

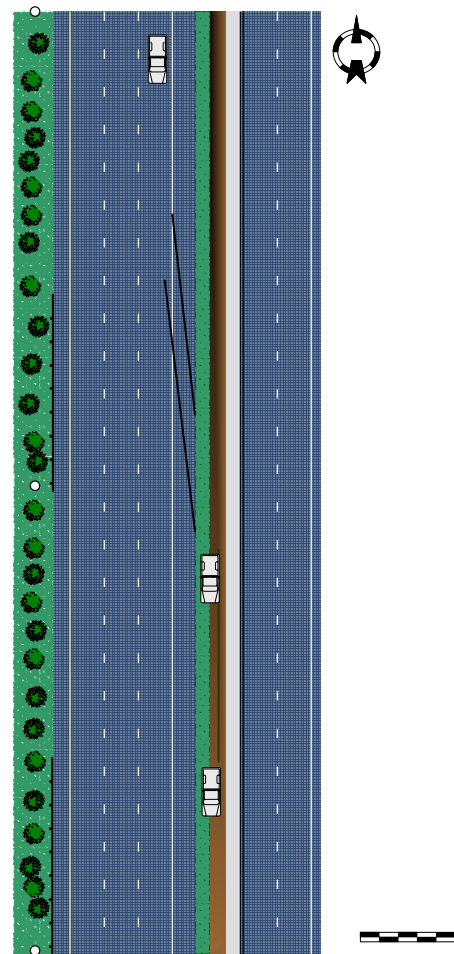
Figure 1: Schematics of Crash Scene

Highway No. 1 is straight, level section with 4 percent cross slope where the run-off road crash occurred. The road surface was dry with asphalt surface which was very recently resurfaced (co-efficient of friction = 0.84). The surface of the ditch was mixed with mud and gravel (some small stones). During the driving situation, there was day

The in-equal skid marks (straight) were found starting from the left shoulder to the roadside embankment. However, the marks also found to be continued inside the ditch (by the left wheels) and on the roadside embankment (by right wheels) until the Point of Rest (POR). The slope of grassy roadside embankment is 13.3~15.0 percent while that of left shoulder was 4 percent. The schematic (plan view) of the crash scene is shown in Figure 1.

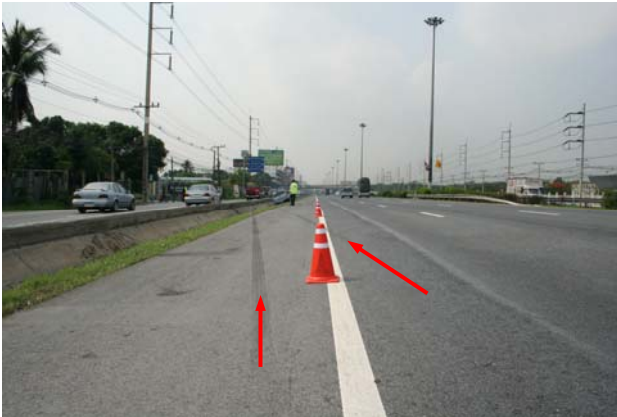
Figure 2: Crash Scene showing the Tire Marks of Running-off Road

Around 30 minutes after the start of his trip, he found the difficulty of having the front-left tire blown out. He applied the brake to control the movement. But he failed to stop even 23.75 m (on an average: left wheel 20.90 m and right wheel 26.60 m) long skid marks on the left shoulder adjacent to the depressed median. Nevertheless, the vehicle continued to go 33.60 m (on an average) more with the left

wheel on ditch and right wheel on the grassy roadside embankment. Figure 2 shows the skid marks found at the scene while the vehicle was going run-off the road. The total length of tire marks found indicating the distance traveled by the errant vehicle from the shoulder to the POR is about 57.30 m.

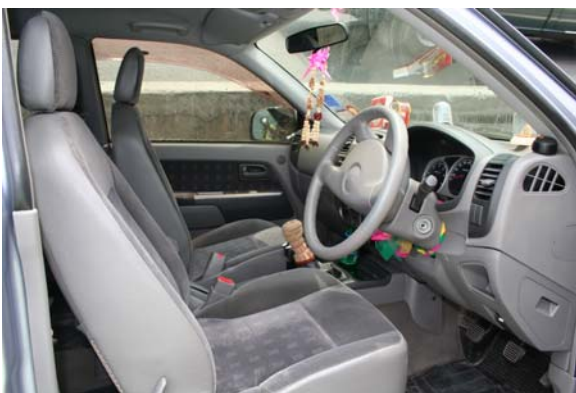
Figure 3: Interior of the Vehicle (Driver side)

There was no report of injury to the driver. However, considering the speed transition from the start of run-off the road (102 km/hr) to the left wheel in the ditch (68 km/hr), the force dissipated to the vehicle was determined about 12.81 KN. The duration of time was calculated to be 1.24 sec over such distance. Since no object was hit by the vehicle on its way entering the ditch, this force generated during such short time did not result in any severe injury to the occupant. The calculation shows 2.81 sec was spent more from the start in the ditch to stop at the POR. The force dissipated to the vehicle was 10.47 KN during this time. No evidence of contacts between the occupant and interior of the vehicle was found. Figure 3 shows the driver's seating position.

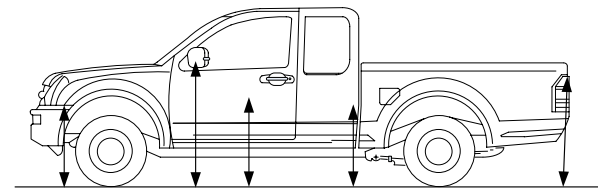
Figure 4: Different Levels of Scratch Marks from Ground

The left side of the vehicle came in contact with the concrete side linings of the ditch. The cover of left side mirror was pushed inward and the cover of the left rear light (at the upper corner) was broken. There were several scratch marks on the left side of body varying from 70 cm to 110 cm from the ground. Figure 4 shows the major scratch marks on the body-structure. Finally, the crashed vehicle required to tow from the crash scene by the towing vehicle.

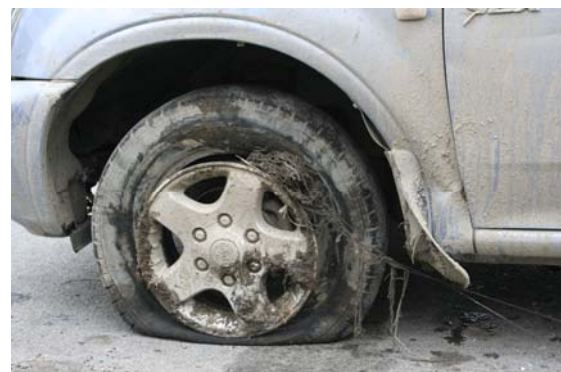
Figure 5: Blown out Left-Front Tire without Rapture

The left tire was found completely air blown out without any visible rupture as shown in Figure 5. The mud on the alloy-wheel assembly shows clearly that the air is completely out as found at its POR. The pressure readings from other three tires were found quite fluctuating. The right-front tire was 24 psi, left-rear 28 psi and right-rear 35 psi. The tread depth of the tire was not found very satisfactory for pickup. All the tires were having 5 to 6 mm deep tread. Since the vehicle went down to the ditch left side of the left-most lane, the front and rear wheels were marked with mud and worn-out grasses.

- Vehicle factor:
 - zero tire pressure of the front-left wheel initially caused the vehicle to lose the control and run into the ditch, left side of the travel direction
 - tire condition (e.g. tread depth) was not satisfactory, indicating poor maintenance
 - tire pressure was imbalanced (i.e. variable pressure at different tires)

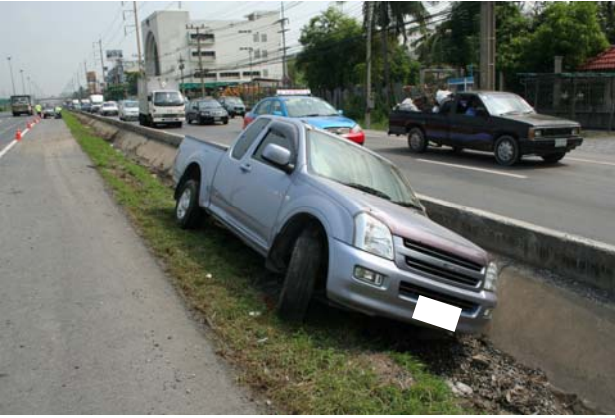
Figure 6: Point of Rest of the Vehicle partly in the Ditch

The vehicle was found at the rest position (i.e. POR) on the roadside embankment. Considering the roll-over, the vehicle made one-eight counter clock-wise of full turn from the initial condition to the POR. Figure 6 shows the POR of the vehicle partially inside of ditch.

- Human factor:
 - traveling speed was found to be 102~105 km/hr. In the situation for front tire blown out, it was too fast to control even after taking evasive action (i.e. braking)
- Road-environment factor:
 - steep roadside embankment was not so friendly for any errant vehicle driver to recover in case of run-off the road that could have resulted in severe roll-over

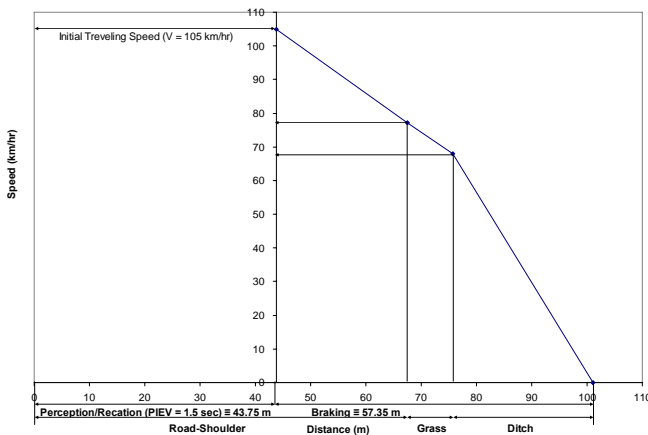
Figure 7: Speed vs. Distance Relationship

Figure 7 shows the relationship between traveling speed and distance traveled by the pickup. Assuming average perception-reaction time for complex situation to be 1.5 sec [4], PIEV distance found to be 43.75 m; while the braking distance was estimated to be 57.35 m. Considering the different friction surface (value given in Table 1), speed was calculated based on the trajectory equations (Newton's equations of motion). Interpreting in reverse direction, it is shown in Figure 7 that the pickup was at POR with zero speed decelerated from 68 km/hr in the ditch. While in the transition zone, it decelerated to 68

km/hr from 77 km/hr at the road-side area. Considering further backward, it decelerated to 77 km/hr from the initial traveling speed of 105 km/hr when it traveled on the shoulder. The total distance traveled from the perception to the POR was estimated to be 101.1 m.
